Manhole Inspection Summary

Manhole # S13A1_010MH

Location Address: **1313 FOREST HILL AVE**

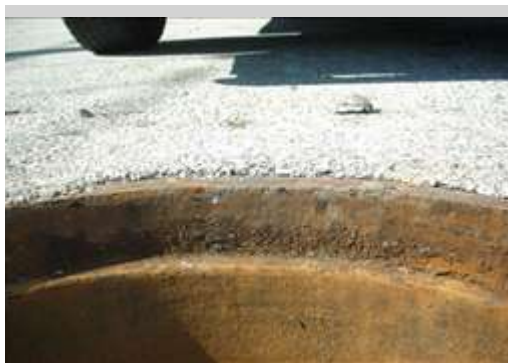
MISC

EVIDENCE OF INFLOW DUE TO SHEETING FROM ROADWAY

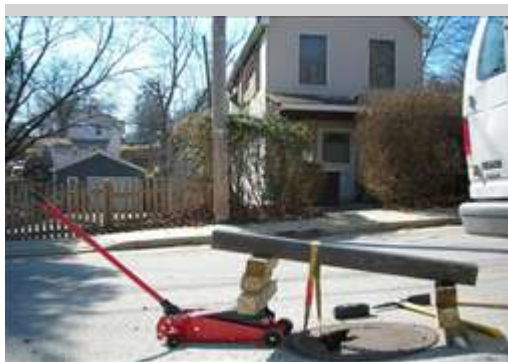
MISC

Comments **BROKE OPEN LID - AND THEN 16LB MAUL ALSO BROKE. PRIED OUT LID USING FORCE. INSPECTION COMPLETE - REPLACED WITH NEW 24" SANITARY LID**

OPENED BY BREAKING OPEN LID, THEN JACKING AND PRYING UP REMAINING PIECES

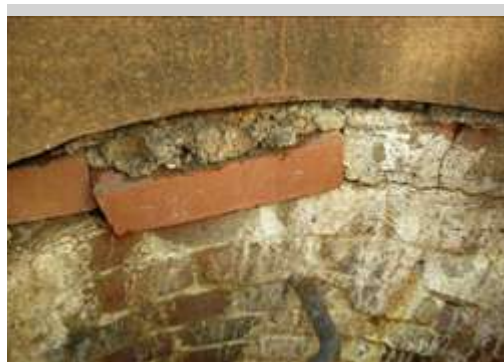
Defect 1

Condition: ☐ Sound ☒ **Cracked** ☐ Root Intrusion ☒ **Loose Brick** ☒ **Deteriorated**

Infiltration: ☐ None ☒ **Joint** ☐ Cracks ☐ Mortar ☐ Roots ☐ Wall

LOOSE BRICKS IN DETERIORATED CHIMNEY ADJUSTMENT - NOTE WHITE STAINED WALLS INDICATIVE

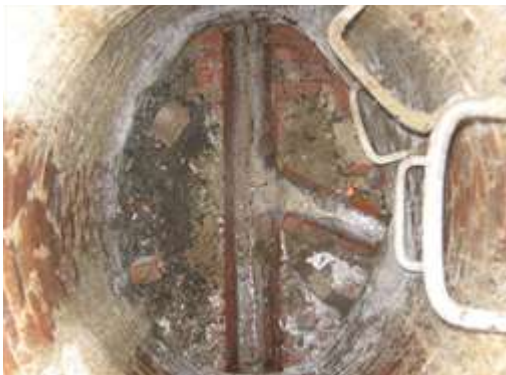
Defect 2

Count: **4** Missing: **0** ☒ **Corroded**

corroded steps

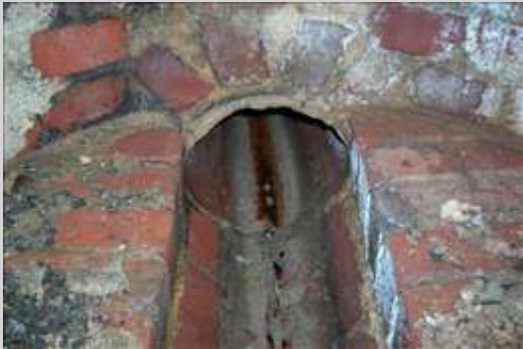
12 O'Clock Outflow

Pipe Height: **9.6** (in.) Rod and Bar (Angled)
Pipe Material: **Clay** ☐ Pipe Lined
Invert Depth: **8.74** (ft.) Flow Characteristics: **Slow**
Deposits: ☒ None ☐ Mud ☐ Sludge ☐ Debris ☐ Grease
Silt Depth: **0** (in.) Deposits Extent:
Infiltration: **None** Pipe Seal Cond: **Sound**

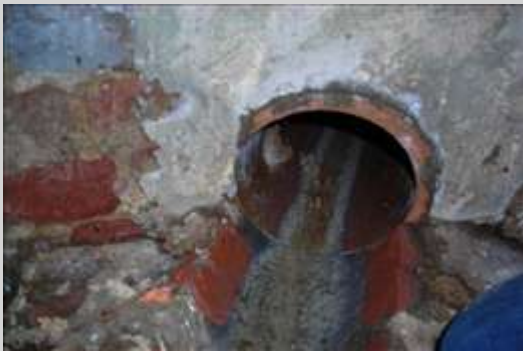
3 O'Clock Inflow

Pipe Height: **6** (in.) Rod and Bar (Angled)
Pipe Material: **Clay** ☐ Pipe Lined
Invert Depth: **7.54** (ft.) Flow Characteristics: **Slow**
Deposits: ☒ None ☐ Mud ☐ Sludge ☐ Debris ☐ Grease
Silt Depth: **0** (in.) Deposits Extent:
Infiltration: **None** Pipe Seal Cond: **Sound**

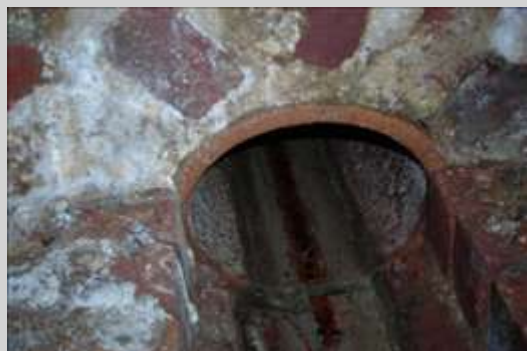
6 O'Clock Inflow

Infiltration: **None** Pipe Seal Cond: **Sound**
